## REPAIRING AN ACTIVE NATURAL GAS CARBON STEEL PIPELINE IN FREEZING WEATHER CONDITIONS

MinskOblGaz is the gas distributor for the district area of the capital of Belarus. With pipelines over 10,000 km, serving over 565 thousand houses and 1400 businesses, it's one of Belarus' largest and most important infrastructural organizations. In the recent wintertime, a 4 mm through-wall defect was discovered in a pipeline supplying natural gas to a huge power plant as a result of a degradation of a welding joint. Urgent repair was necessary as the risk of explosions were severe, but the working conditions were harsh and there was no possibility to temporarily shut down the pipeline. CTE BV offered a fast and secure engineered solution to repair the leak according ISO TS 24817.

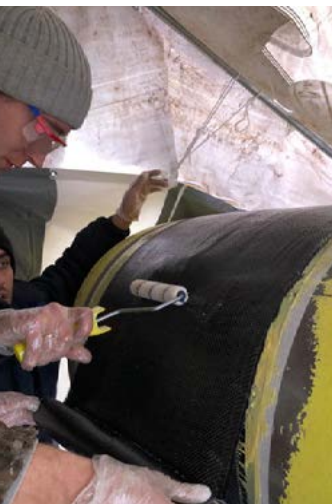
The leak was discovered by the gas inspection team. The 720 mm pipeline above ground showed several weak points at the girth welds. A result of insufficient quality of welding; each 12 meter section of pipe needs to be welded, but this was not the case here. A 4 mm pinhole directly at the welding joint was found and leaking gas. As a first measure, textile straps and rubber patches were used, but this was not working at all because of the size of the leak and other circumstances.

The leak was repaired using **DiamondWrap®HP™ carbon fiber system** and a **leak sealing steel clamp**. First, the clamp and silicone rubber pad were applied to seal the leak. After this, the surface was prepared for long term repair. By applying epoxy putty and the 500mm width composite repair solution the welding joints/girth welds were reinforced. Due to the outside temperature of -4 C, this was done inside a special tent to create an environment with the needed minimum temperature of +10 C. The tent remained on the pipe for another eight hours with heating inside to let the composite materials cure properly.
