## REINFORCING A HIGH PRESSURE TRANSMISSION NATURAL GAS PIPELINE TEE

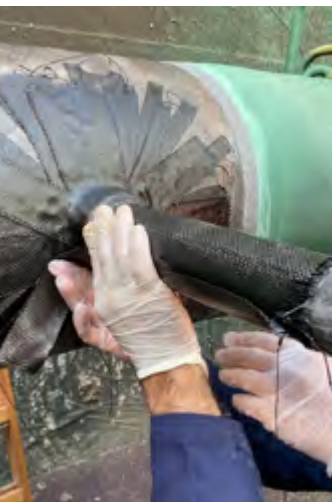
The subject of the repair was a welded joint on a reducing tee (reduction from 18 inches - 2 inches). The tee was made of carbon steel and operated at an elevated value of operating pressure of 90 bar with a maximum design pressure of 95 bar. The large difference in the diameters of both pipes is a significant obstacle in the repair process.

After the intensive dialog between engineers, the repair technology was presented to the customer. The pipeline surface was prepared with sandblasting, and the roughness of the surface was carefully measured prior to proceeding with the repair. Due to the big difference in pipeline diameters, it was necessary to use a special way of wrapping: axial patches mixed with circumferential wrap. Because of the high pressure in the pipeline, the repair was conducted with the use of a high number of layers of epoxy-based engineered carbon-fiber material **RevoWrap110**.

The certified supervisor/trainer of CTE BV was sent over to the repair location in order to educate and support the local contractor. Thanks to this, the repair not only strengthened the welded joint but also extended its service life, in accordance with the international technical standard **ISO 24817**. After concluding the repair at one block valve station in the presence of the trainer, the local maintenance company conducted eighteen repairs at the other stations. The costs of material and installation turned out to be the lowest of all discussed repair alternatives.
