## REINFORCING A HIGH PRESSURE TRANSMISSION NATURAL GAS PIPELINE TEE

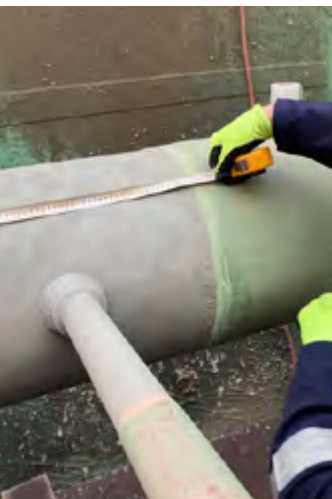
The subject of the repair was a welded joint on a reducing tee (reduction from 18 inches - 2 inches). The tee was made of carbon steel and operated at an elevated value of operating pressure of 90 bar with a maximum design pressure of 95 bar. The large difference in the diameters of both pipes is a significant obstacle in the repair process.

After the intensive dialog between engineers, the repair technology was presented to the customer. The pipeline surface was prepared with sandblasting, and the roughness of the surface was carefully measured prior to proceeding with the repair. Due to the big difference in pipeline diameters, it was necessary to use a special way of wrapping: axial patches mixed with circumferential wrap. Because of the high pressure in the pipeline, the repair was conducted with the use of a high number of layers of epoxy-based engineered carbon-fiber material **RevoWrap110**.
